# **INDOOR AIR QUALITY ASSESSMENT**

**Nelson Place Elementary School  
35 Nelson Place  
Worcester, Massachusetts**

Prepared by:  
Massachusetts Department of Public Health  
Bureau of Environmental Health Assessment  
December 2002

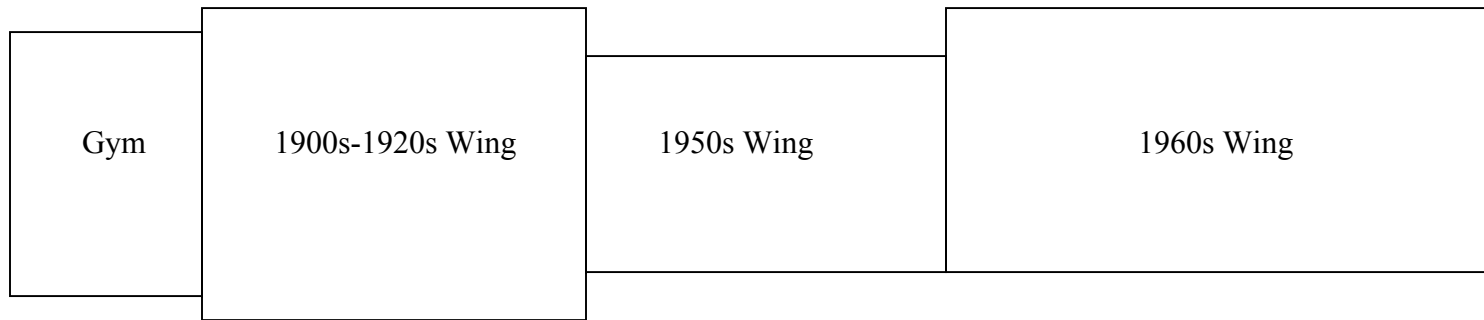
**Figure 1**  
**Schematic of Layout of the Nelson Place Elementary School**  
(Drawing Not to Scale)

The school is a complex of three wings constructed at different times (see Figure 1). The original building is a brick exterior two-story building constructed in the 1900s-1920s. A single story brick exterior wing was added to the building in 1950s (rooms 9-12 and cafeteria). A third wing, a brick exterior two-story structure, was added in the 1960s. Windows are openable throughout the building.
